# Dissolution of Printed Circuit Board Copper Barrel Plating Found with Multiple/Extended Exposure Thermal Stress Testing

Renee J. Michalkiewicz and Scott S. Opperhauser, Trace Laboratories – East  
Hunt Valley, Maryland

Zequn Mei and Mason Hu, Cisco Systems, Inc.  
San Jose, California

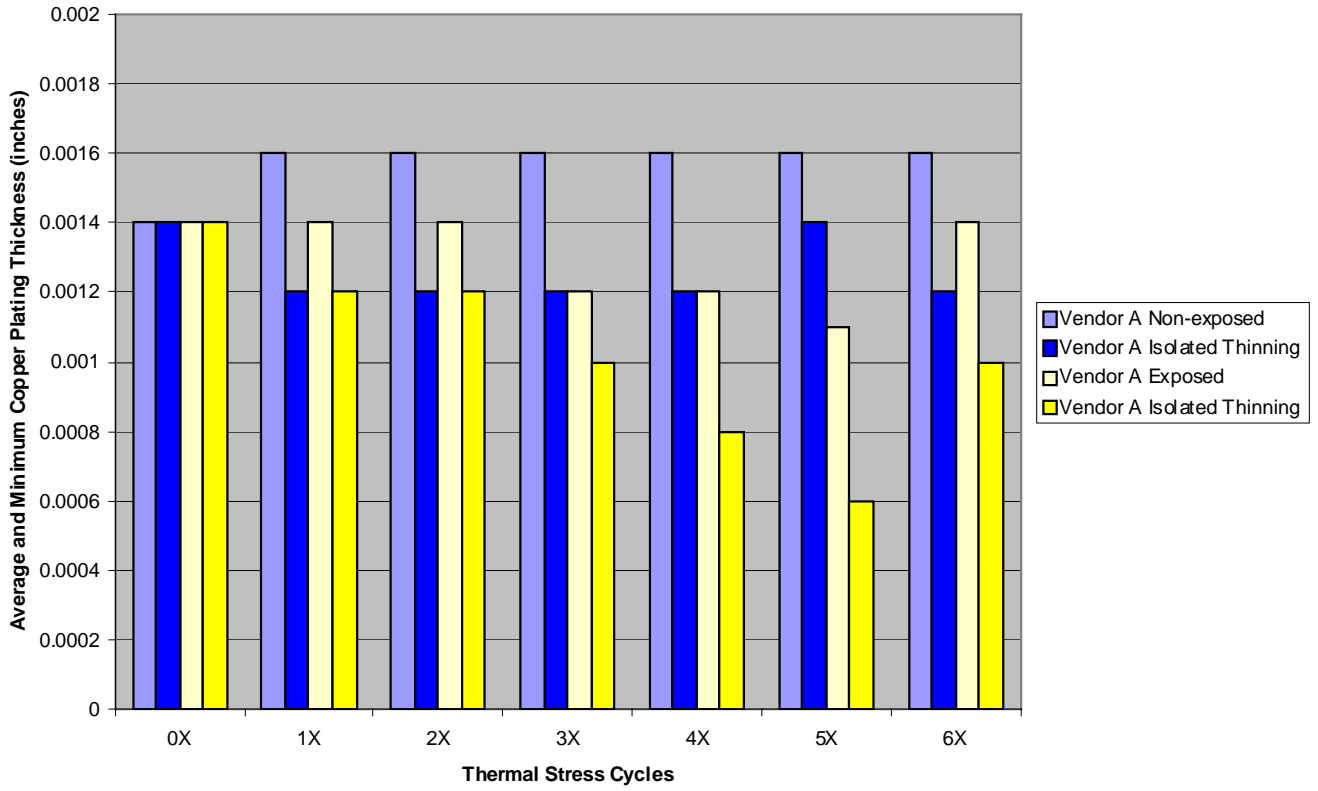
**Figure 1: Graph of Table 3 Data**

A reduction in average copper plating thickness of 0.2mil was found at 1X thermal stress. The maximum reduction in the average was observed at 5X and measured 0.5mil. A reduction at the knee (Isolated thinning) of 0.8mil was found at 5X thermal stress cycles. This value of 0.6mil failed to meet the OEM specification and was cause for rejection. See Table 3, Figure 1 and photos 1-13, below. Figure 1 at 2X through 5X shows the only real linear trend observed in plating reduction although the 6X value does not fall in line with the curve.

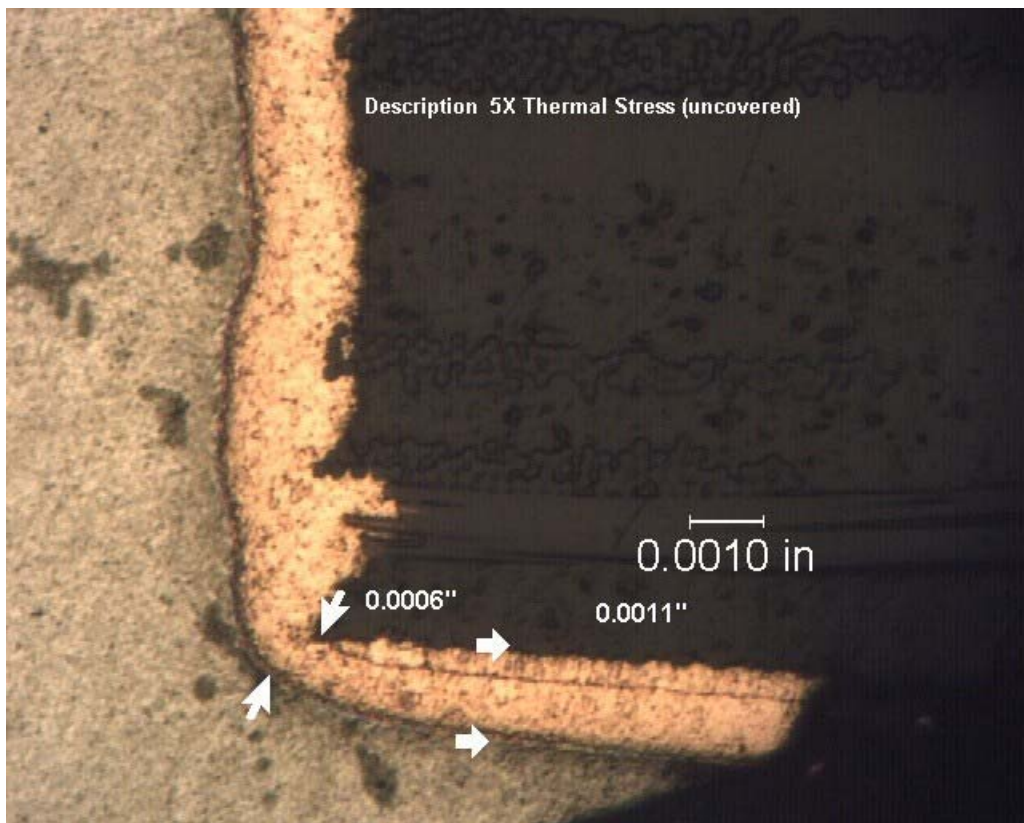
**Photo 11: Vendor A, 5X Thermal Stress, Uncovered, Showing Thinning at the Knee Below Minimum Requirements**

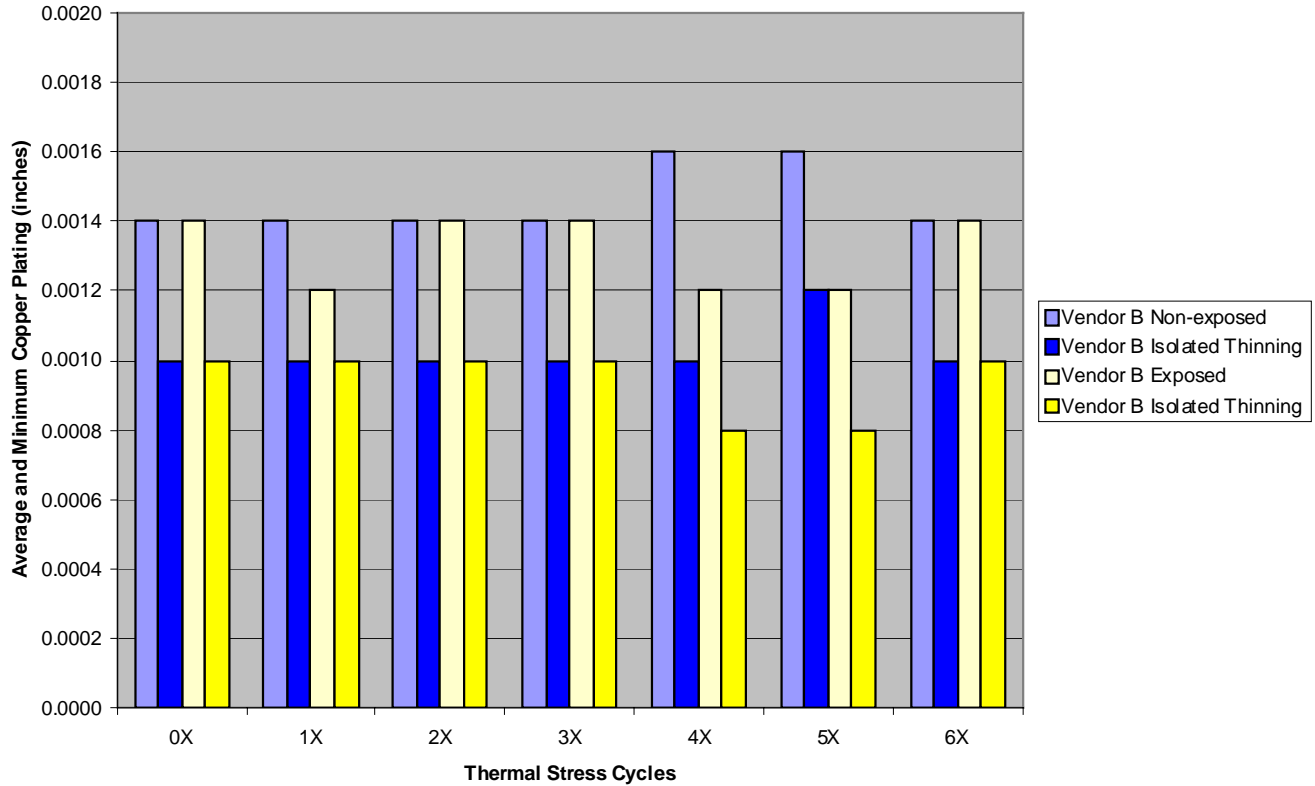
**Figure 2: Graph of Table 4 Data**

A reduction in average copper plating thickness of 0.2mil was found at 1X thermal stress. The maximum reduction in the average was observed at 4 and 5X and measured 0.4mil. Results from this study did not lead to rejection of the product, although when initially tested this product was rejected due to isolated thinning at the knee measuring less than 0.8mil. See Table 4 and Figure 2.

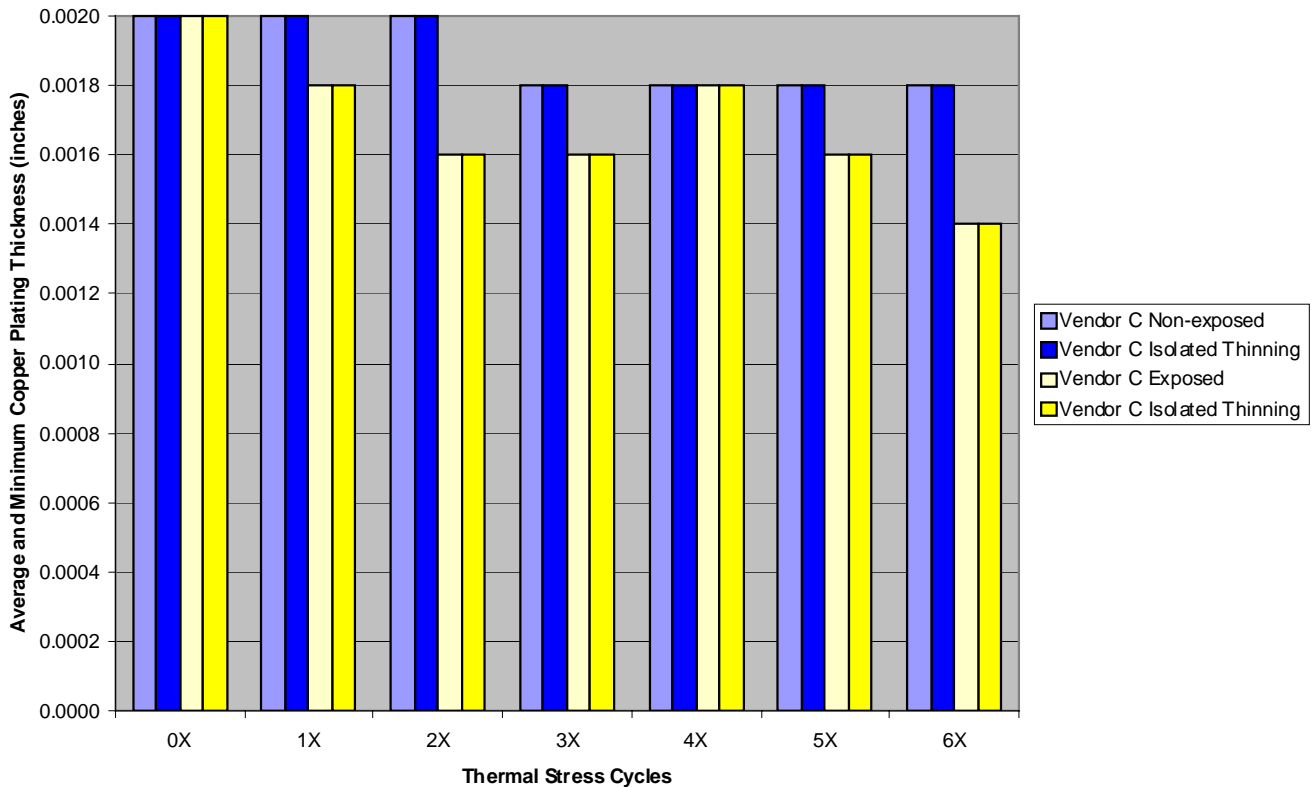
**Figure 3: Graph of Table 5 Data**

A reduction in average copper plating thickness of 0.2mil was found at 1X thermal stress. The maximum reduction in the average was observed at 2 and 6X and measured 0.4mil. The initial plating thickness of 1.8 to 2.0mils was well above the minimum requirement; therefore, the loss of copper thickness did not lead to rejection of the product. . See Table 5 and Figure 3.
